## Optimizing Preventive Maintenance to Reduce Downtime On CAT KT4 Axle Loader Components in The Mining Industry

**Abstract.** Damage to rotatable axle components on CAT KT4 Loaders in the mining industry is often the main cause of operational downtime. This study aims to analyze the frequency of damage to axle components and evaluate the effectiveness of preventive maintenance to reduce downtime duration and repair costs. Damage data collected from January to August 2024 were quantitatively analyzed to identify the most frequent damage patterns, especially seal leaks and brake modules. The results show that the implementation of preventive maintenance, such as regular seal replacement and hydraulic pressure checking, can significantly reduce the frequency of breakdowns and improve operational efficiency. The research also provides recommendations on maintenance strategies that can be implemented to extend component life and reduce overall downtime.

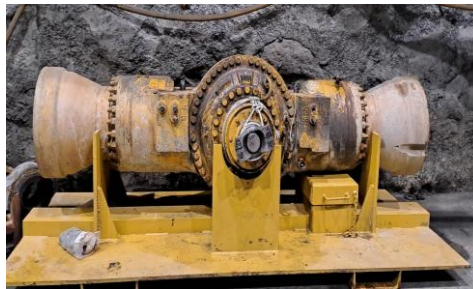
**Fig 1 Main Components of the Power Train System of the R1700**

Based on Figure 1, there are several axle components including, the suspension functions to absorb shocks when the Loader moves, the brake system functions to control or stop the movement of the vehicle, the differential functions to regulate the difference in wheel rotation speed when turning, the rear final drive axle (rear axle) functions to increase stability and traction, the front final drive (front axle) functions to support the front weight of the vehicle and transfer power from the front differential to the front wheels, and the axle which functions to support and transfer power from the engine to the wheels. These axle components are susceptible to damage that can affect the overall performance of the loader (Muhlis, 2020). Table 1 below summarizes the frequency of damage and duration of downtime for each type of damage identified.

In the CAT KT4 Loader there are several axle components which can be seen in Figure 1.

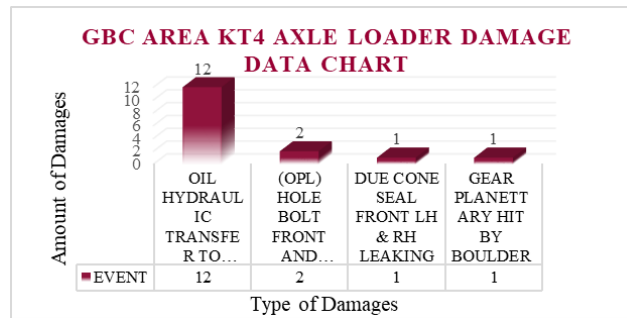
**Fig 2 Total Component Damage Axle loader KT4 Area GBC**

Based on table 1 and figure 2 shows damage data that has been classified into 4 types with each different total damage. The types of damage that occur are Oil Hydraulic Transfer to Front and Rear Axle with a total damage of 12, Hole Bolt Front and Rear Rh Tire Broken (OPL) has a total damage of 2, Due Cone Seal Front Lh & Rh Leaking and Gear Planetary Hit by Boulder with the same total damage of 1.

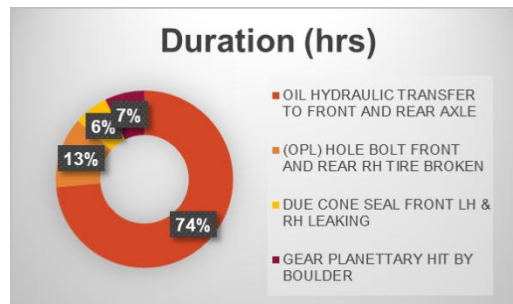
**Fig 3 Percentase Downtime Axle loader KT4 Area GBC**

Based on table 1 and figure 3 shows the duration data (HRS) or damage time until repair in 4 types of damage to the KT4 Loader rotatable axle components. Data with total duration (hrs) type of damage to Oil Hydraulic Transfer to Front and Rear Axle is 346.74 and a percentage of 74%. As for damage type (OPL) Hole Bolt Front and Rear Rh Tire Broken has a total duration (hrs) of 60.86 and a percentage of 13%, damage type Due Cone Seal Front Lh & Rh Leaking has a duration (hrs) of 29.46 and a percentage of 6%, and damage type Gear Planetary Hit by Boulder has a duration (hrs) of 34.22 and a percentage of 7%.

Based on the analysis of the breakdown data from January to August 2024, it was found that the most frequent type of breakdown was Oil Hydraulic Transfer, which is the improper transfer of hydraulic oil from the axle system. This malfunction occurred 12 times during the

study period, accounting for 74% of the total downtime. This condition was caused by a seal leak that caused oil from the hydraulic system to mix with axle oil, affecting the overall performance of the braking system and axle.
